**YORKTOWN CENTRAL SCHOOL DISTRICT
YORKTOWN HEIGHTS, NEW YORK**

REPORT ON PCB WIPE SAMPLING: AUGUST 30, 2005

FRENCH HILL ELEMENTARY SCHOOL

September 2005

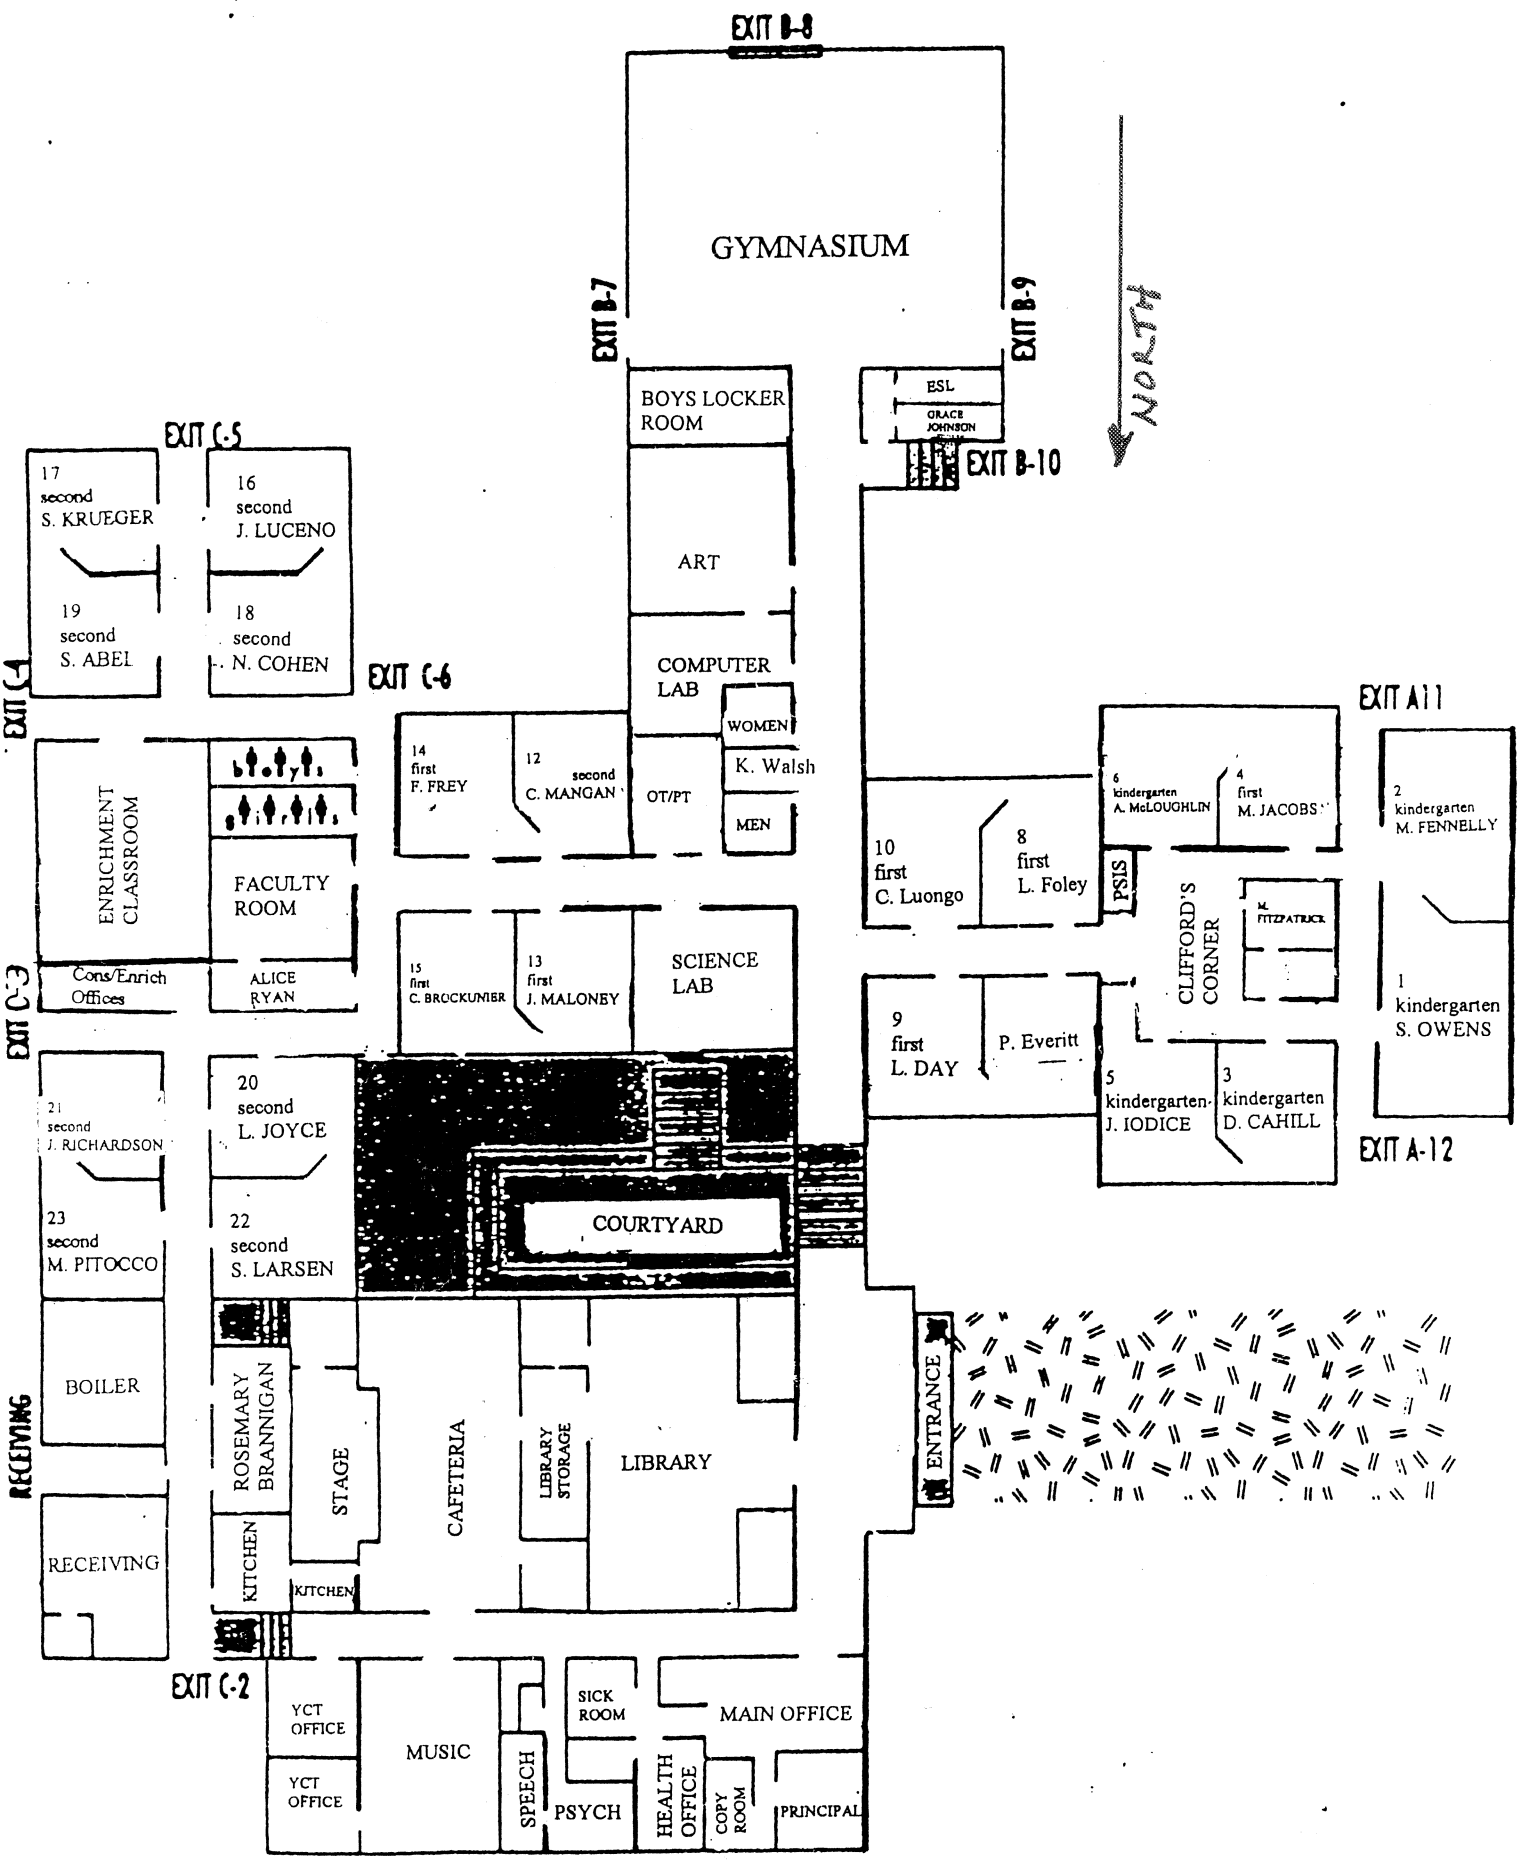
The locations of the samples are indicated on the attached table. The attached sketch map provided by YCSD provides on orientation for these locations. Sampling was biased to locations near the soil remediation areas. Four of the wipes were collected at Room 23 where the highest levels of PCB contamination to the soil had been measured (40 mg/kg). The sampling encompassed one room exhaust vent (at Room 23), which is typical of the ventilation systems of most of the other rooms in the structure. One wipe sample was collected from the aluminum flashing of the roof.
