28th International
Symposium on
Halogenated Persistent
Organic Pollutants (POPs)

**POLYCHLORINATED BIPHENYLS (PCBS) AND INDOOR AIR:
SOURCE INVESTIGATION AND REMEDIAL APPROACH FOR A
PUBLIC SCHOOL BUILDING IN NEW BEDFORD,
MASSACHUSETTS, USA**

David M. Sullivan
TRC Environmental Corporation
Lowell, MA USA

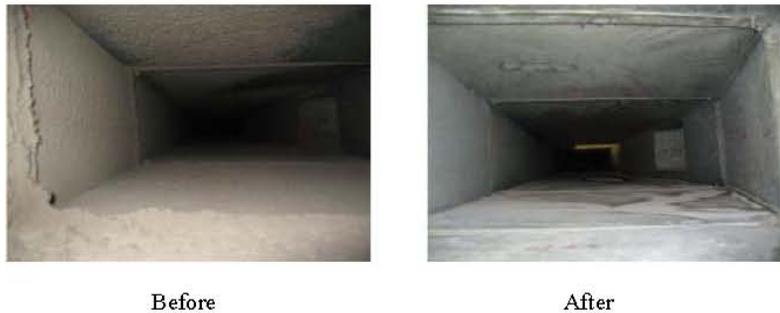
Figure 1: Before/After Photographs - Ventilation System (Duct Work)

The remedial activities significantly reduced the PCB burden associated with dust deposits (see Figure 1). This included removing approximately 3,400 pounds of PCB-contaminated solid material (e.g., dust) from the air handling system and spent HVAC filter media. Total PCB concentrations found in these dusts ranged from 0.78 mg/kg to 36.5 mg/kg (average 7.4 mg/kg) and were attributable to:

- **Ducts:** Cleaned all supply, return, and exhaust ducts in the school (13,572 feet of ductwork).
- **HVAC Components:** Cleaned 20 central HVAC components, fans coils, and intakes.
- **Perimeter Univent and Corridor Heaters:** Cleaned and replaced filters for 250 units.
- **Return Exhaust Vents:** Cleaned 120 return air exhaust vents (approximately 8,700 linear feet).
- **Surface Cleaning:** Cleaned approximately 93,000 sq. ft. of dusty surfaces.
- **Sub-locker Space:** Cleaned enclosed spaces under 4,000 hallway lockers with long-standing reservoirs of dust.
- **Wood/Auto Shops:** Cleaned unique dusty locations of fixed surfaces.
- **Filter Replacement:** Replaced all filters within the HVAC system no matter the age or condition.

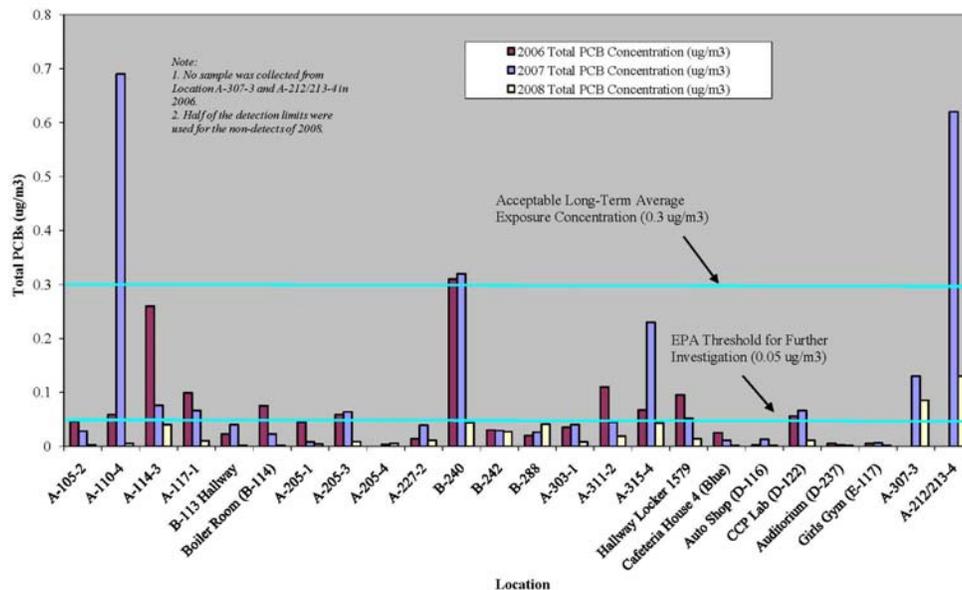
Figure 2: Graphic Summary - Comparison of TRC NBHS Indoor Air Results August 2006, August 2007, and February 2008

The results from post-remedial air monitoring conducted in summer 2007 were varied. In some locations, reductions in air phase PCB concentrations were observed, while in other locations concentrations remained essentially the same or increased when compared to air-phase PCB data collected in summer 2006 prior to the implementation of remedial actions (see Figure 2).

Further investigation found that 20 out of 120 (approximately 17-percent) of the roof exhaust vents were not working during the August 2007 PCB air sampling events. Over 40-percent of perimeter univents were found to be non-functioning, many of which were operating during air sampling conducted in August 2006. The lack of a fully functioning ventilation system contributed to the unchanged or increased air phase PCB concentrations given that PCB-containing building materials are still present in the building. A third round of PCB indoor air monitoring conducted in February 2008, following the restoration of the HVAC system to full operational capacity and system re-balancing, showed dramatic improvements in indoor PCB air quality (see Figure 2).
